Finished Wall Restoration

EVERLAST™ BASEMENT WALL SYSTEM

Restore the bottom of your finished walls, without ripping the entire basement out and starting over!

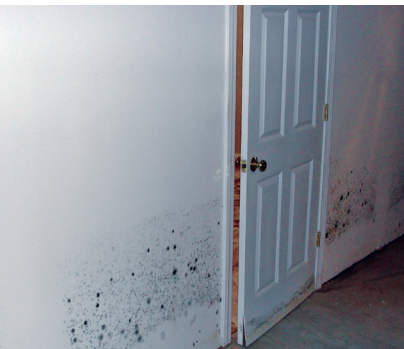
STEP 1

BEFORE: Bottom of existing walls damaged, from water and high humidity.

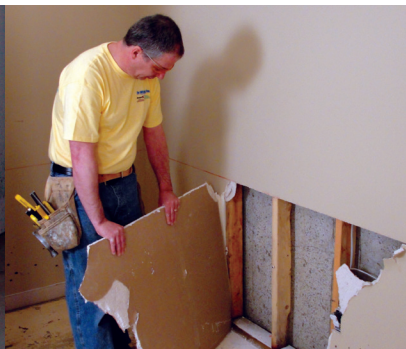
STEP 2

Cut and remove the moldy, damaged drywall and bottom of the studs.

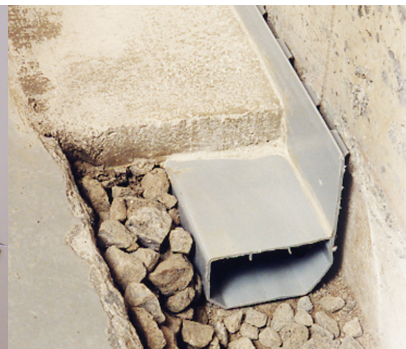
STEP 3

With the bottom of the finished wall removed, a perimeter drainage system can be installed – as needed.

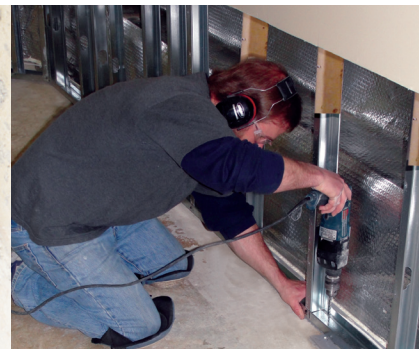
STEP 4

Replace the bottom of the wood studs with metal studs.

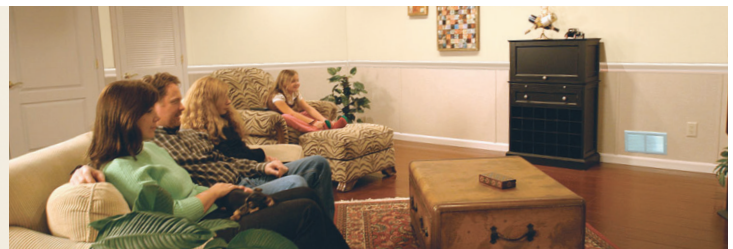
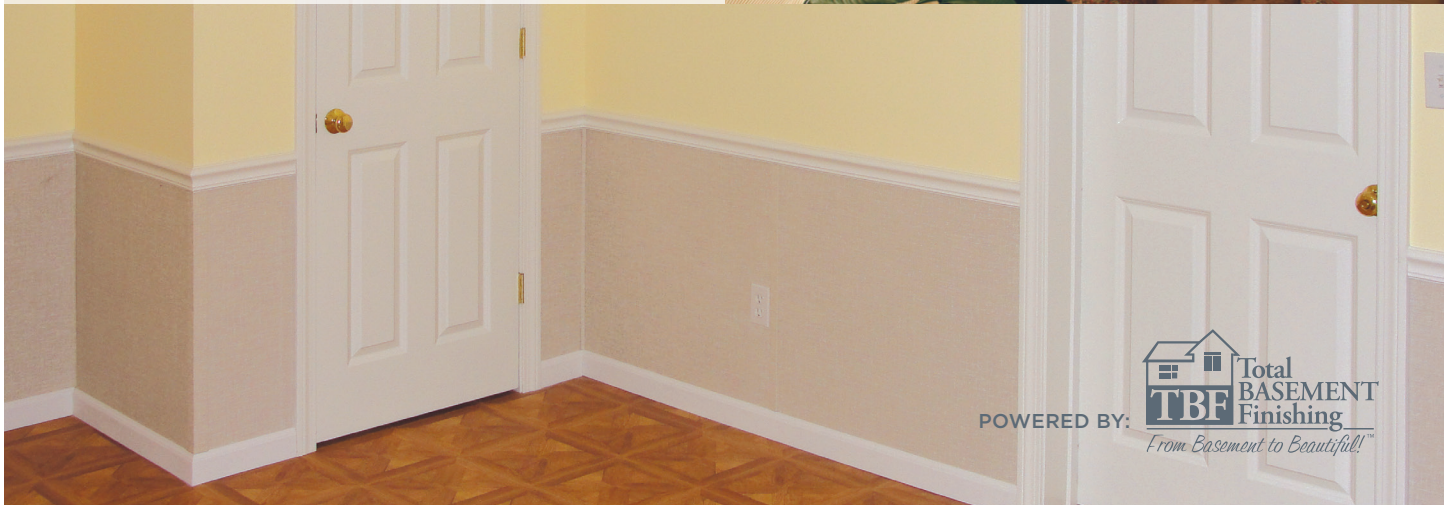
STEP 5

Install mold-proof EverLast Wall Panels up to 32", finish with pvc chair rail and trim. Install optional ThermalDry or MillCreek Flooring.
